Toxic Substances Control Act  
PCB Inspection

G & G Auto/FNJ Enterprises

Investigation: December 13 & 18, 2013  
Gerard Crutchley - OECEJ(3EC10)  
Final Report - 1/14/14

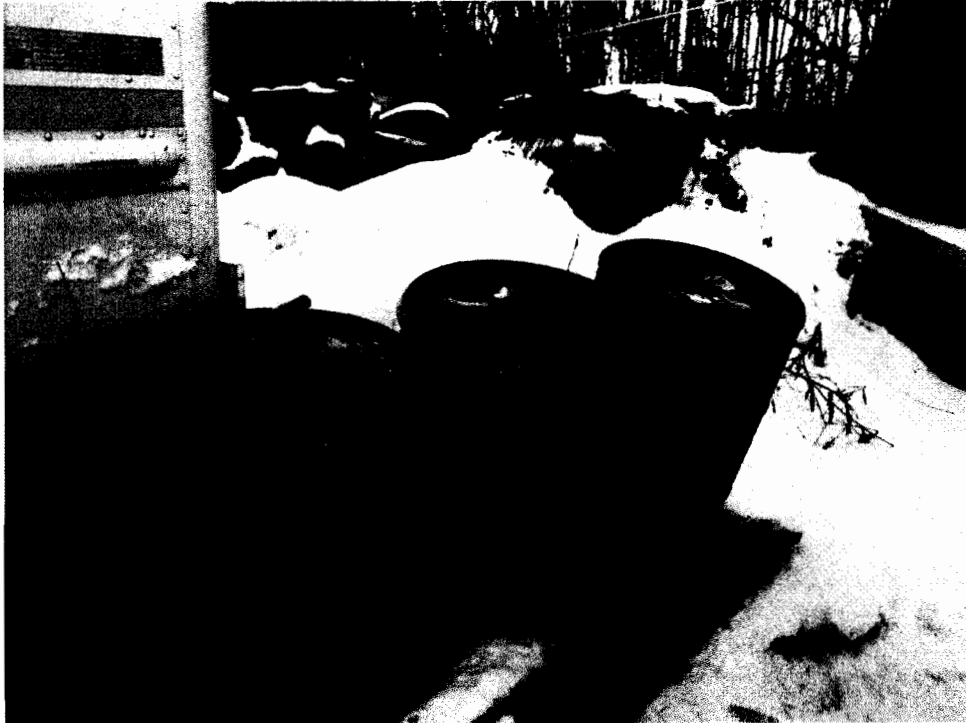
Photo No. 1 – G & G Auto  
Justin Young – 12/13/2013

The inspectors next observed the three drums that Mr. Jean Louis stated had previously contained the oil that he had poured into the waste oil tank. The drums were located outside near the building next to a truck (See Photo No. 1). There were no markings or labels on any of the 3 drums to indicate what might have been contained in the drums.

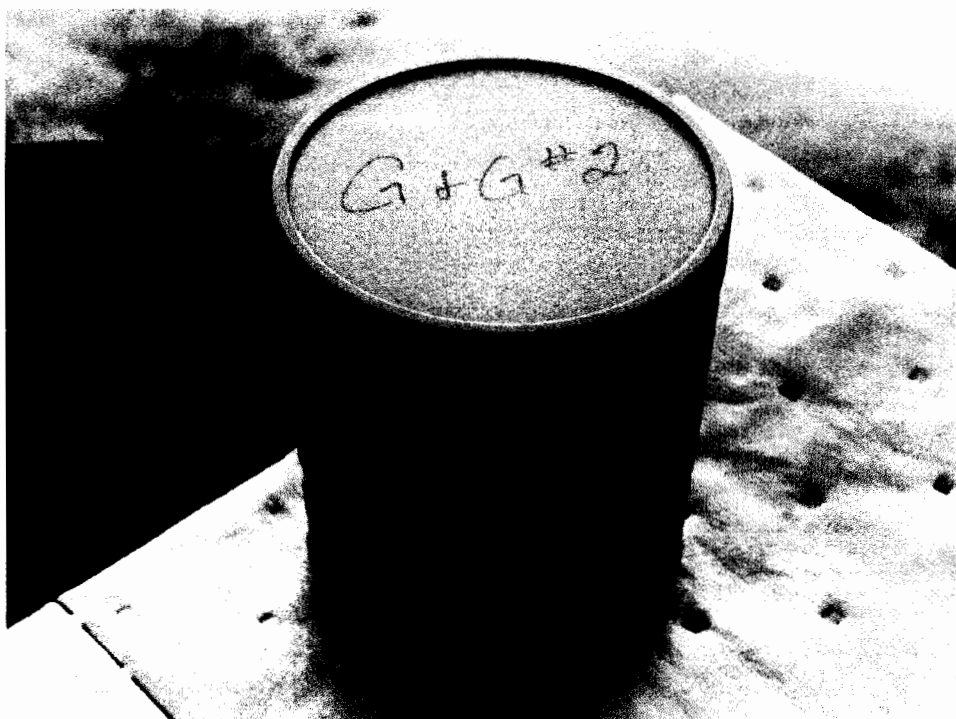
Photo No. 3 – G & G Auto  
Justin Young – 12/13/2013

Mr. Young then attempted to collect a sample from the middle blue 55 gallon drum. Mr. Young used a new glass drum thief and was able to collect a sample of material remaining in the drum. The sample, identified as G&G #2, was collected by Mr. Young at 3:28pm (See Photo No. 2). The sample was placed into an eight ounce amber glass container (See Photo No. 3).

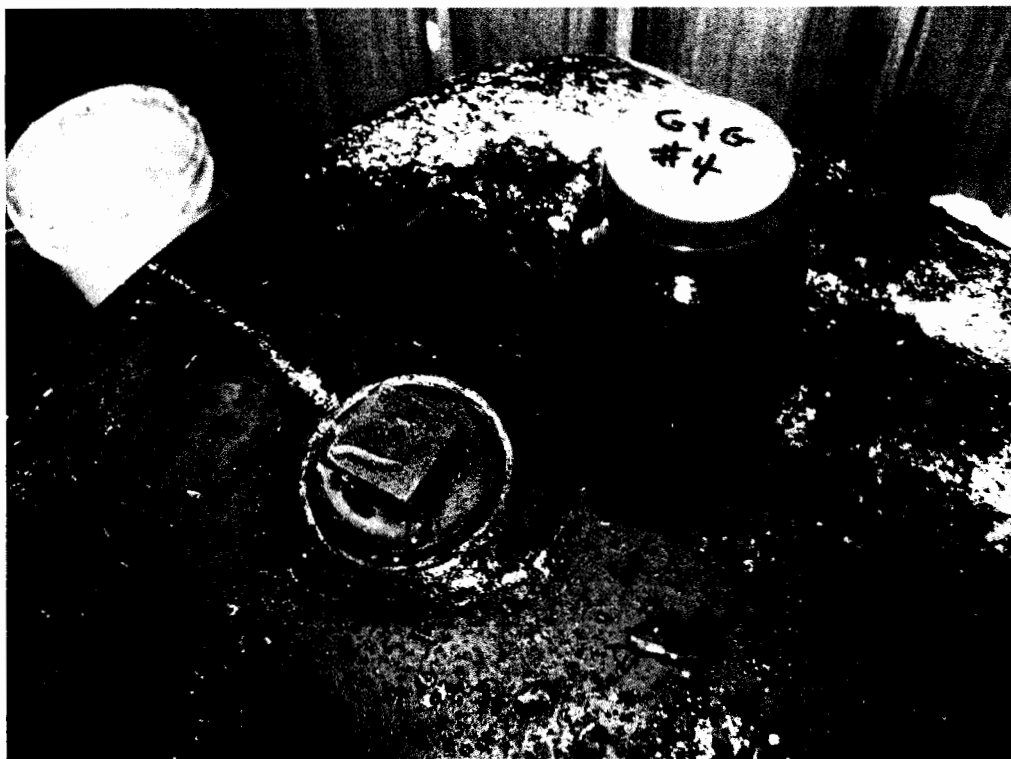
Photo No. 13 – G & G Auto  
Gerard Crutchley – 12/18/2013

The EPA inspectors then utilized the plastic coliwassa tank sampler to collect a sample of the oil from the tank. The sample, identified as G & G #4 was collected in the sampler and then placed into an eight ounce amber glass container (See Photo No. 13). The sample was collected at 11:05am by the EPA inspectors (Justin Young & Gerard Crutchley).

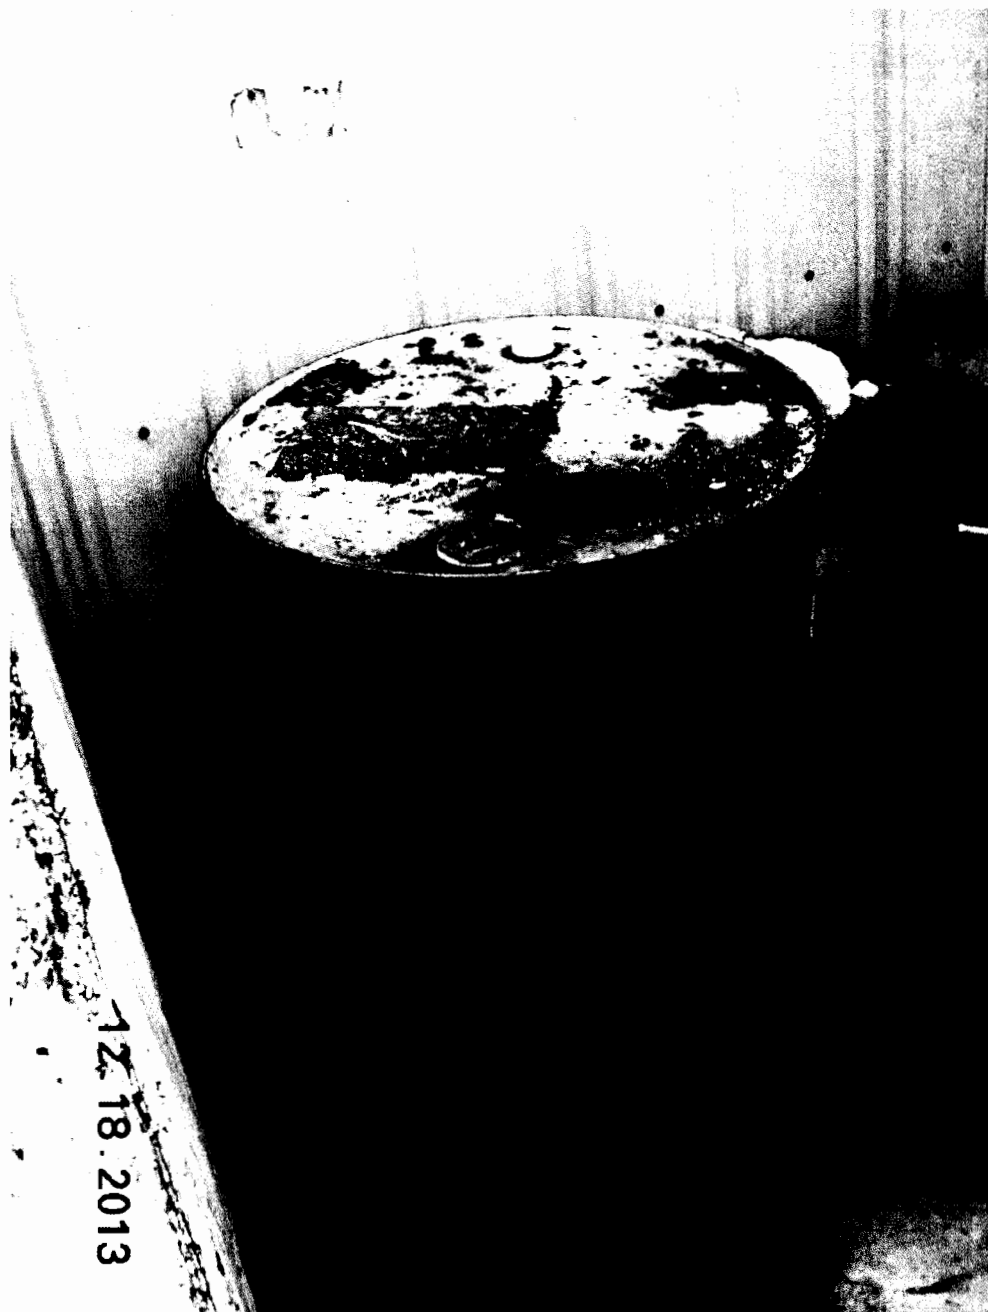
Photo No. 14 – G & G Auto  
Gerard Crutchley – 12/18/2013

The EPA inspectors also observed a 55 gallon metal drum next to the waste oil tank (See Photo No. 14). When asked about the drum, Mr. Louis stated that since he was instructed to not use the waste oil tank, he is currently using the drum to accumulate any waste oil they he generates from his car repair business. According to Mr. Louis this drum is one of the two drums that contained the oil that was removed by Crystal Clean in October, 2013. The EPA inspectors next used a bung wrench to open the larger bung on top of the drum and then used a clean glass drum thief sampler to measure the amount of oil in the drum. The depth of oil in the drum was measured at 0.8 feet. Using the same equation for calculating the amount of oil in the waste oil tank, the amount of oil in drum was calculated to be approximately 15 gallons. Using the glass drum thief sampler, the EPA inspectors collected a sample of the oil from the drum. The sample identified as G & G #5 was collected in the sampler and then placed into an eight ounce amber glass container (See Photo No. 15). The sample was collected at 11:15am by the EPA inspectors (Justin Young & Gerard Crutchley).
